Report No: 4788939006
Report Date: 2020-02-15

Test Location Information	
Name	China Academy of Information and Telecommunication Technology
Address	CuiHu Cloud Center, No. 1 Gaolizhang Road, Wenquan Town, Haidian District, Beijing
Client Information	
Name	NAVITAS GREEN SOLUTIONS PVT. LTD
Address	B-20/3, Road No: 14, Hojiwala Industrial Estate Sachin Udyognagar Sahkari Mandli Limited Sachin Palsana Road Surat, Gujarat, 394230 India.
Report Information	
Report Number	4788939006
Report Date	2020-02-15
Standard References	IEC 62716 first edition: 2013-06 Photovoltaic (PV) modules – Ammonia corrosion testing, IEC61215 second edition:2005 -04 Crystalline silicon terrestrial photovoltaic (PV) modules – Design qualification and type approval IEC61730-2 first edition:2004-10 Photovoltaic (PV) module safety qualification – Part 2: Requirements for testing
Test Product Information	
Type	NSM380
Product	Mono-crystalline photovoltaic module
Testing Engineer	
Name/Signature	Wu Yapan (from subcontract lab)

Ammonia resistance test procedure

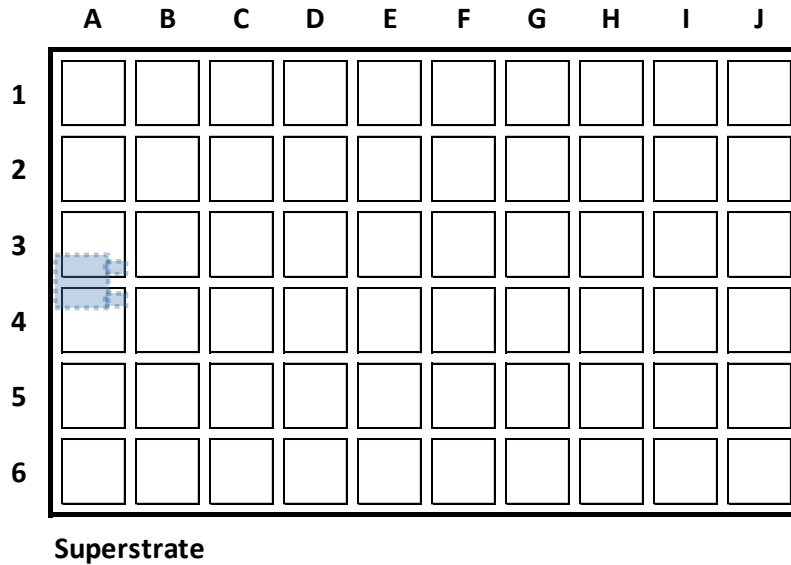
Figure 3 "Cell positions"

The following figure illustrates the cell position on the module.

Sample No.	Condition Visual Inspection
2733660	No major visual defects
2733659	No major visual defects
2733658	No major visual defects

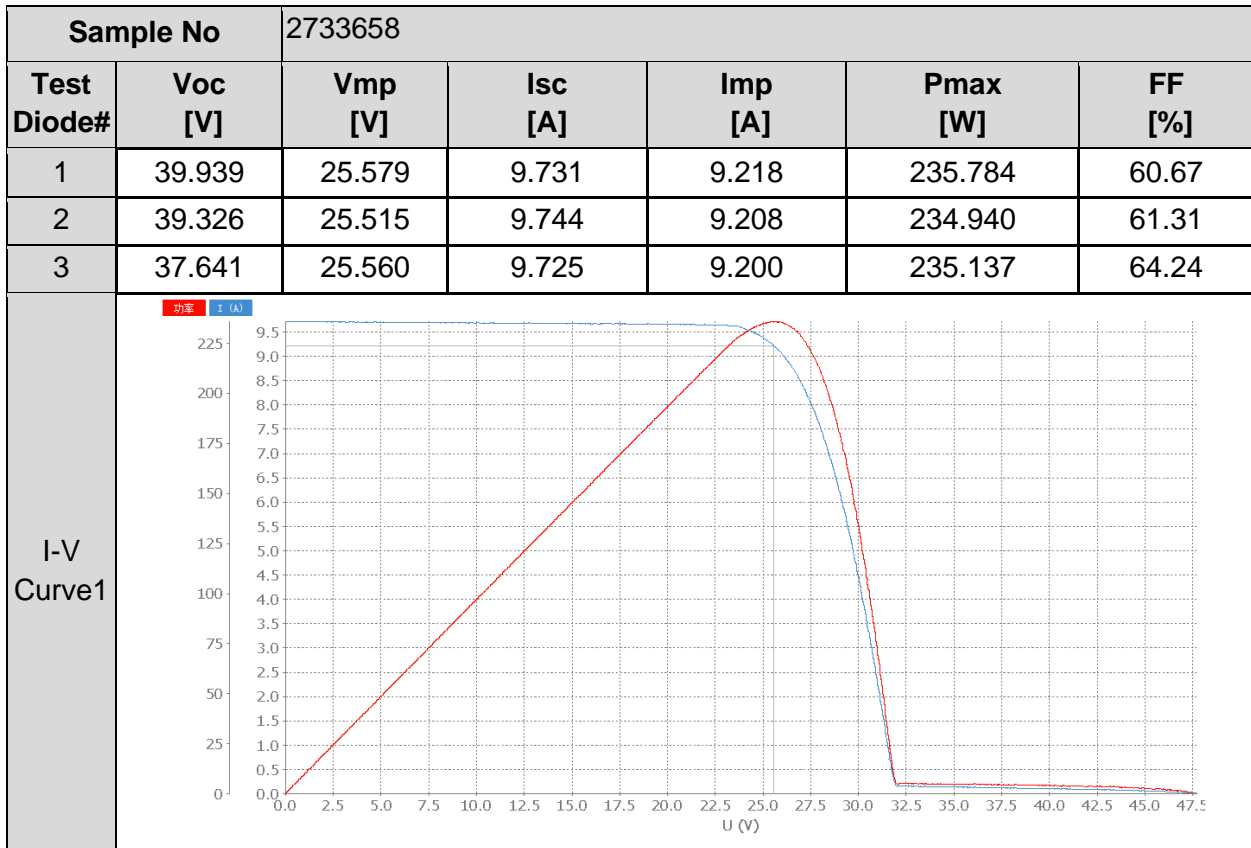
Sample No		2733659				
Test Diode#	Voc [V]	Vmp [V]	Isc [A]	Imp [A]	Pmax [W]	FF [%]
1	39.881	25.702	9.623	9.103	233.959	60.96
2	39.586	25.587	9.616	9.105	232.970	61.20
3	38.287	25.699	9.621	9.096	233.754	63.46

Sample No		2733658				
Test Diode#	Voc [V]	Vmp [V]	Isc [A]	Imp [A]	Pmax [W]	FF [%]
I-V Curve2						
I-V Curve3

The diode did still function as a diode after the conclusion of the test.

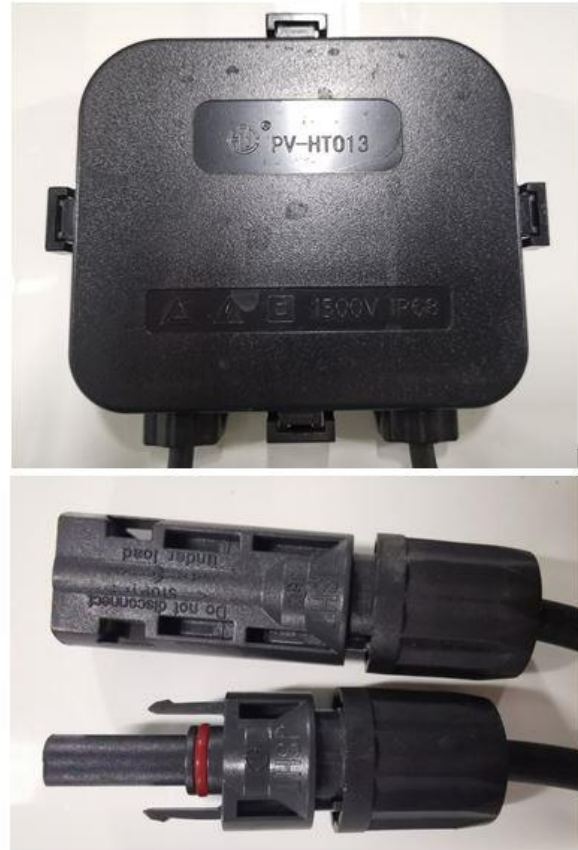
Junction box and connector

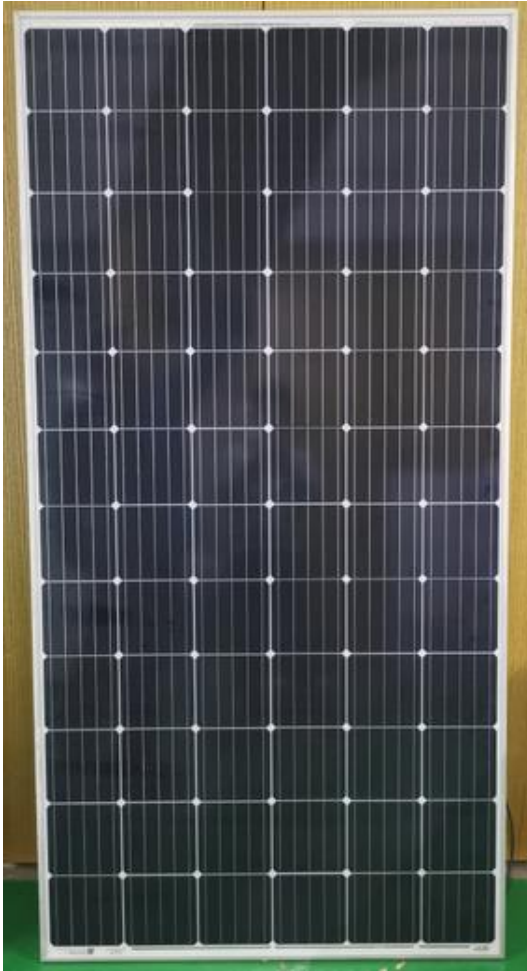
Module front view

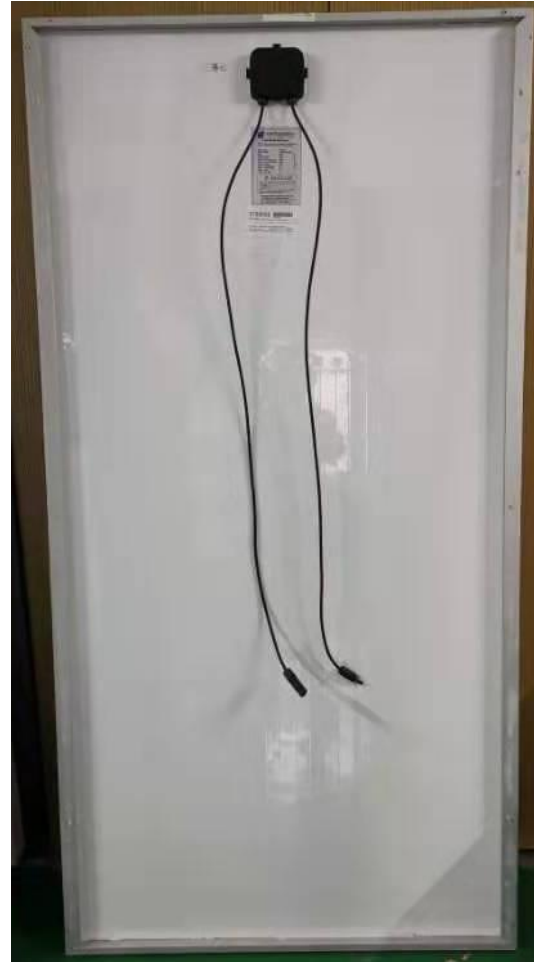
Module rear view
